The Sports Pavilion, Oxford Road, Eynsham,

**Summary Report on Condition of the Building**

19<sup>th</sup> December 2023

**Shields Longden and Co**

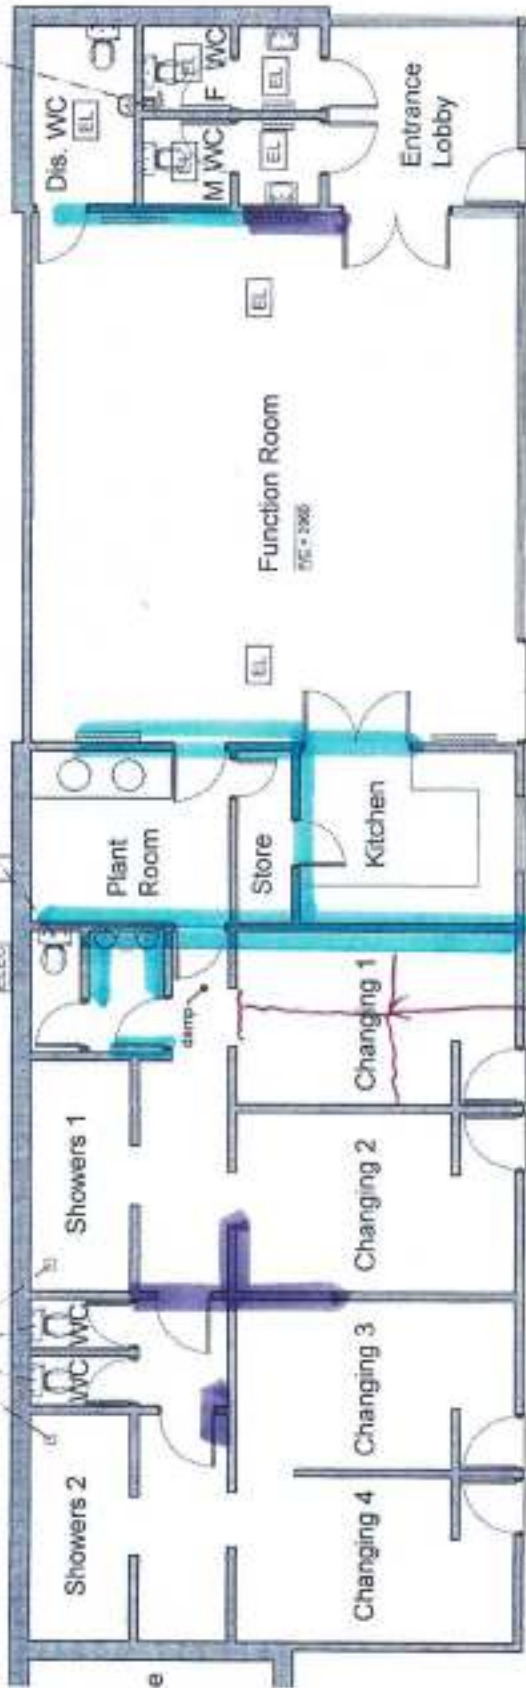
LOCATION OF MOVEMENT

- 3.7 By reference to the annotated floor plan, the location of the cracking is in blue. This shows the cracking/movement is **limited to the central parts of the building**, with the cracking to the disabled person's toilet being consequential to this.

MAY 2019.

CRACKING TO FLOOR

DEC 2023 NEW MOVEMENT

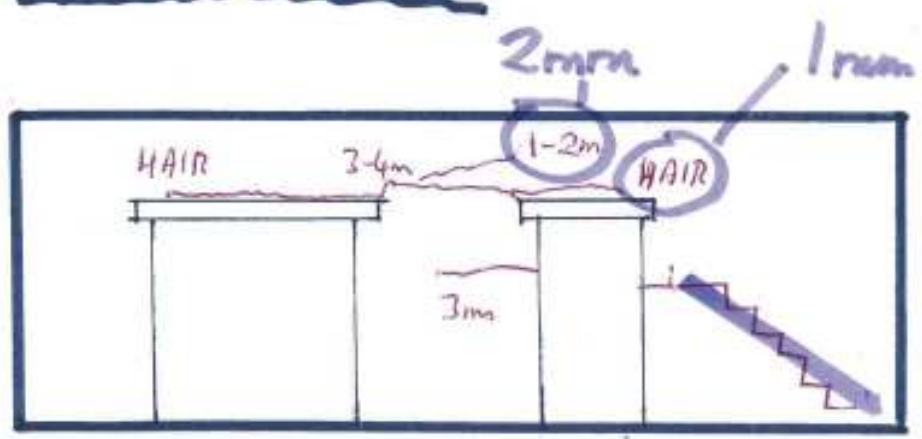
HALL, WEST WALL

FILLED + OPENED UP

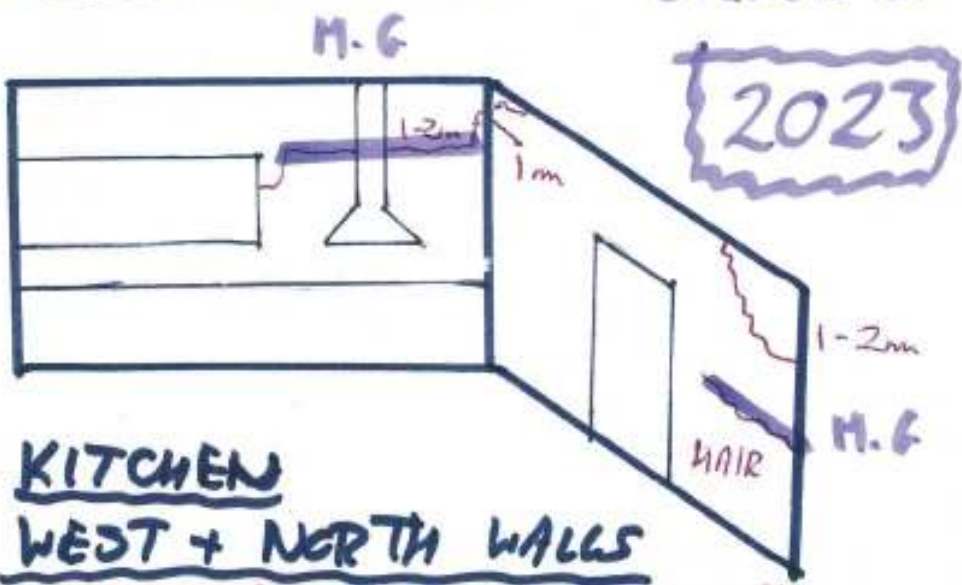
KITCHEN WEST + NORTH WALLS

ORIGINAL SKETCH 2019

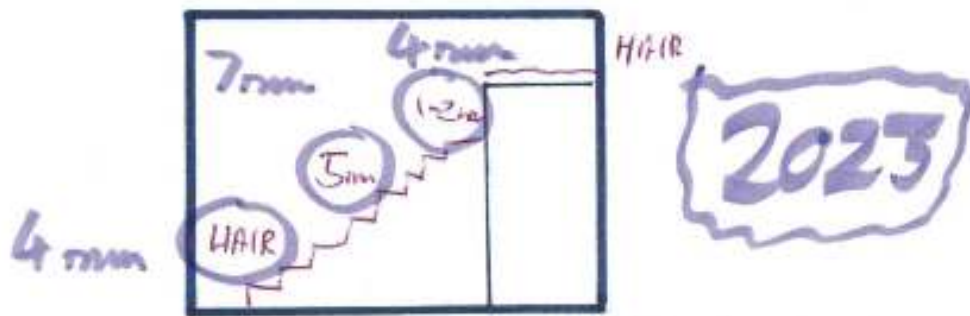
**BOILER ROOM, EAST WALL**

4mm GAP TO DOOR HEAD M.G.

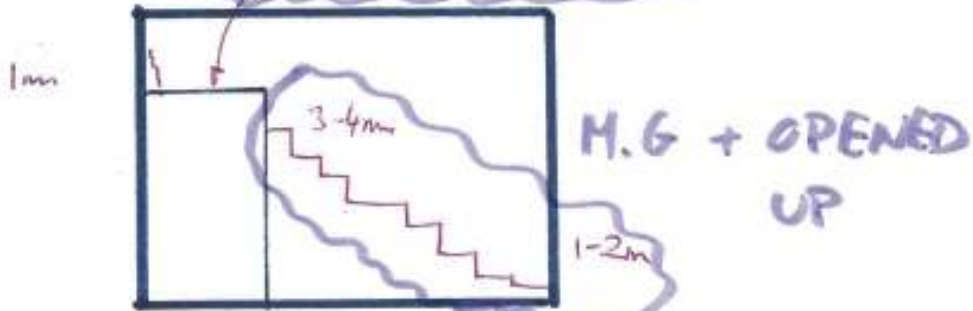
**BOILER ROOM, WEST WALL**

M.G + SLIGHT OPENING UP

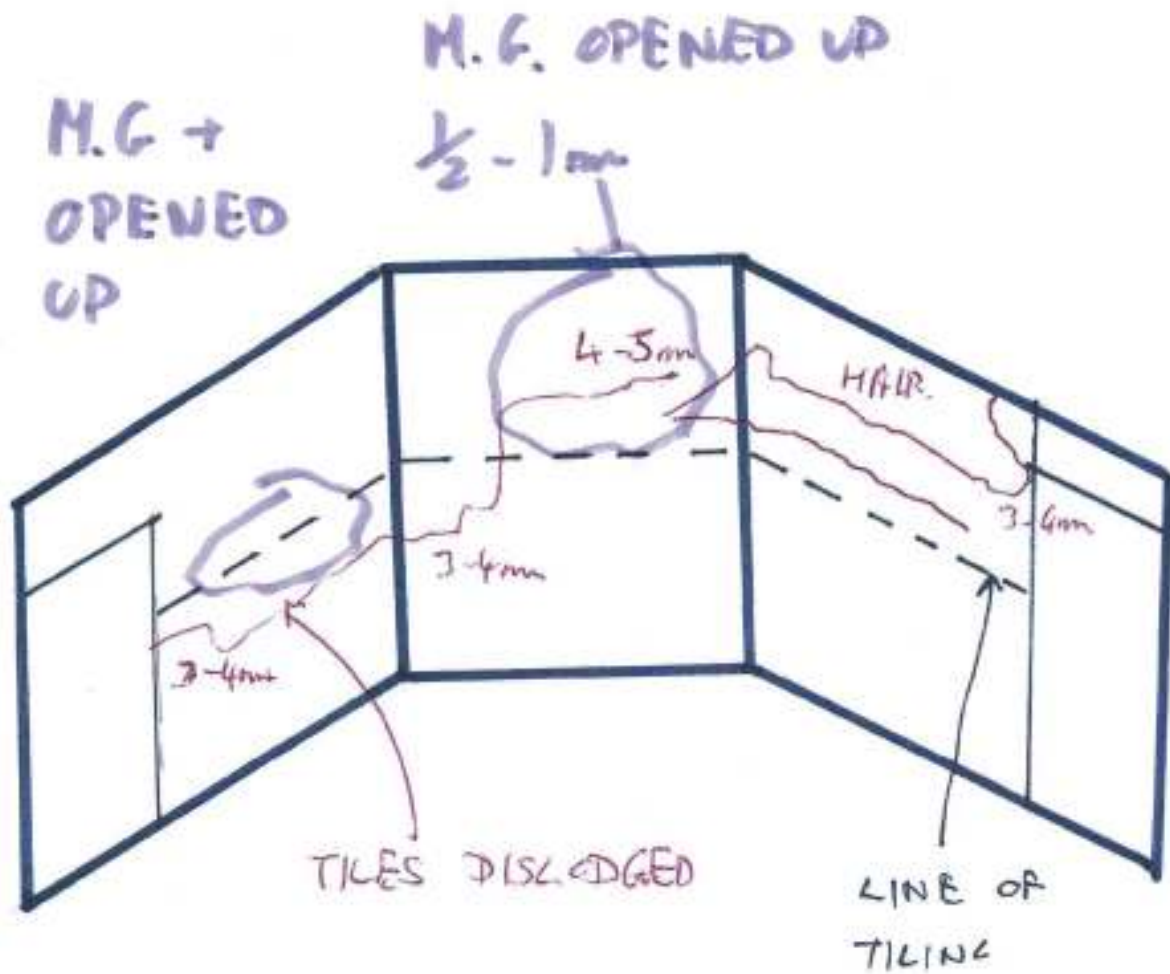
**MENS URINAL AREA**

**2023**

**ORIGINAL SKETCH 2019**

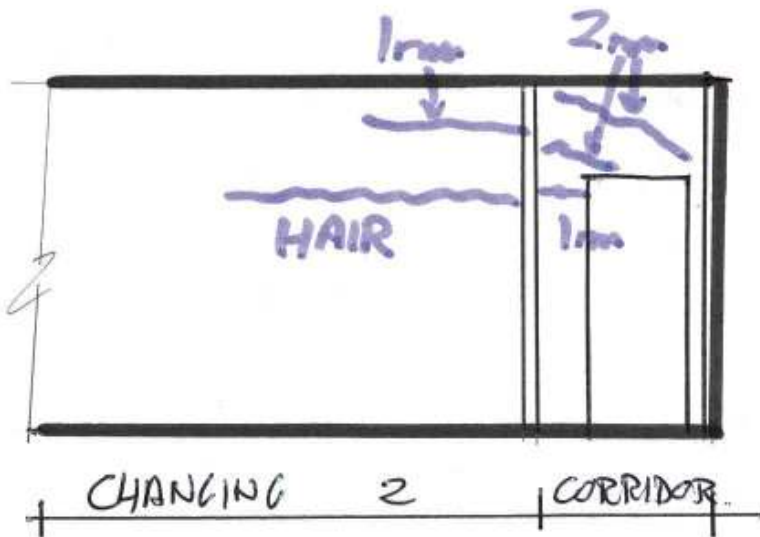
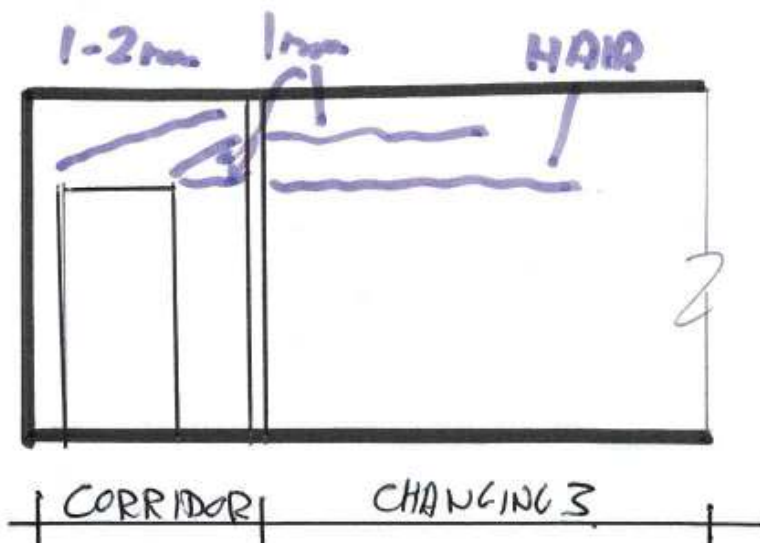
New Cracking 2023

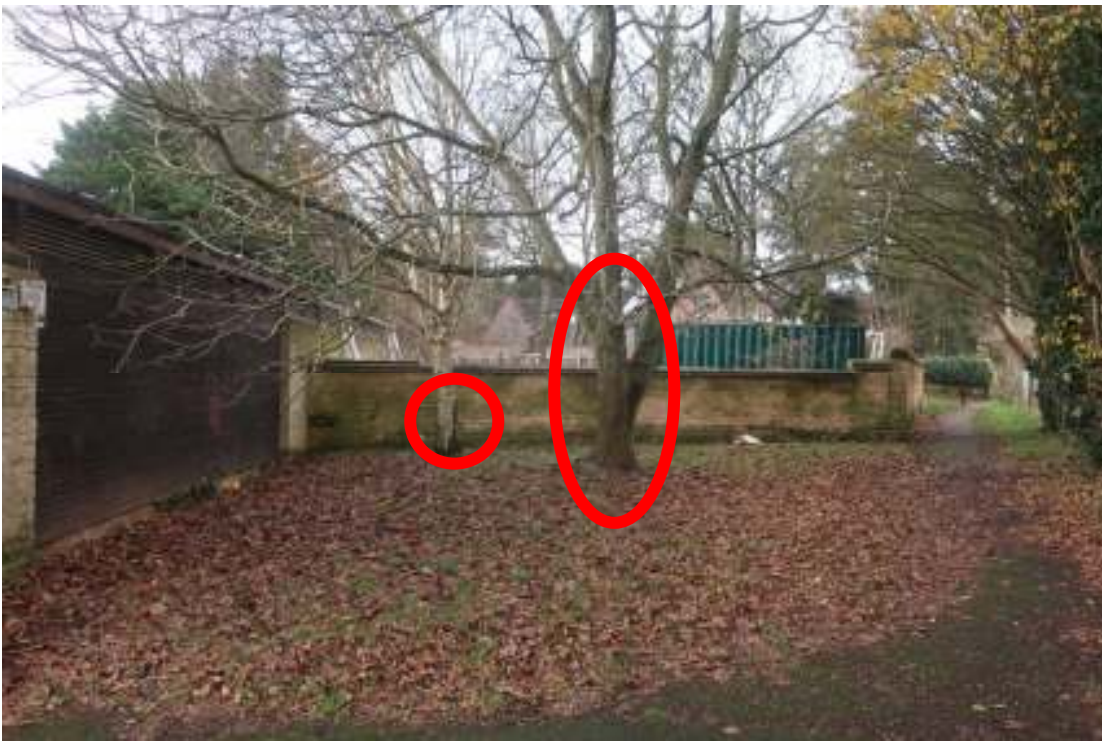
- 3.16 There are two likely contributory causes of the movement and these should be addressed:-
- a. To the rear of the building there are **two large trees**. These are too close to the building and **should be removed**.
  - b. There is a drain to the rear. A **CCTV camera survey** should be carried out to check for defects and/or escape of water
- 3.17 These two items should be addressed without further delay.

**Remove 2 x trees**

- b. **2 x trees to rear, remove**, as too large and close to the building
  - c. Floors, generally slightly uneven, to function room and to changing rooms

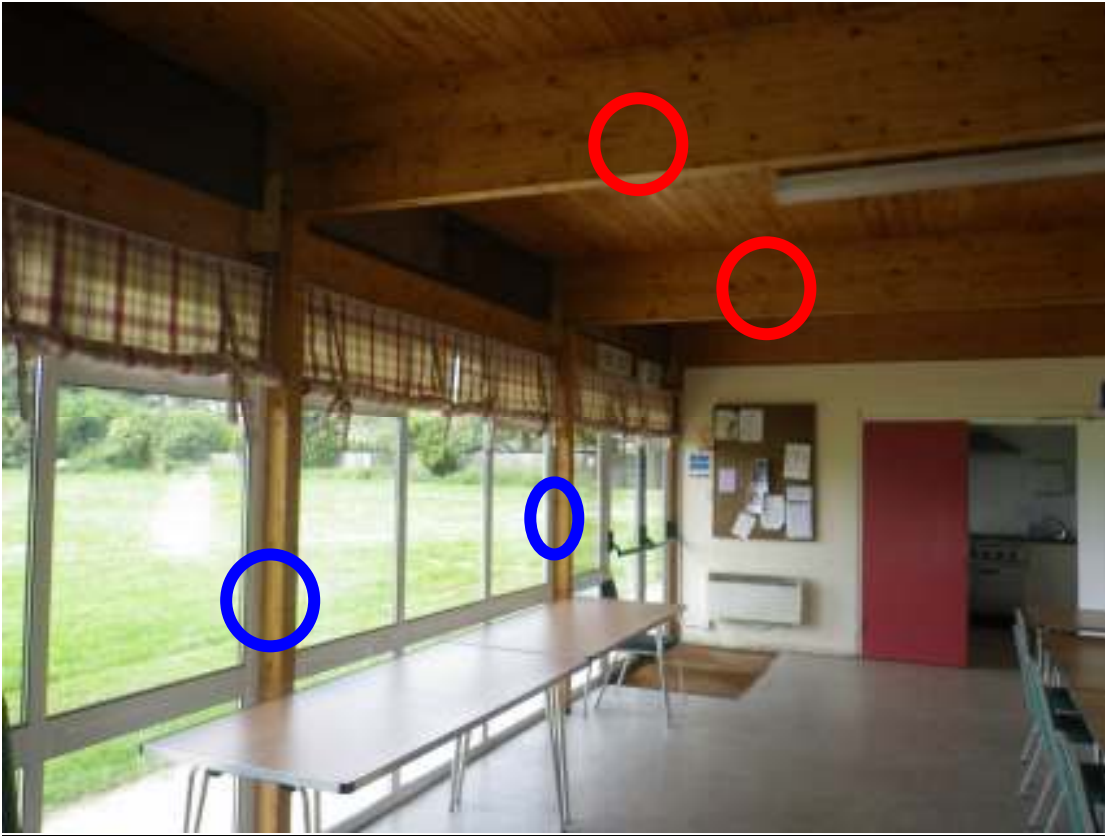
**General view to show the structure**

Roof supported by timber glulam beams, **red**

Columns around the perimeter, **blue**

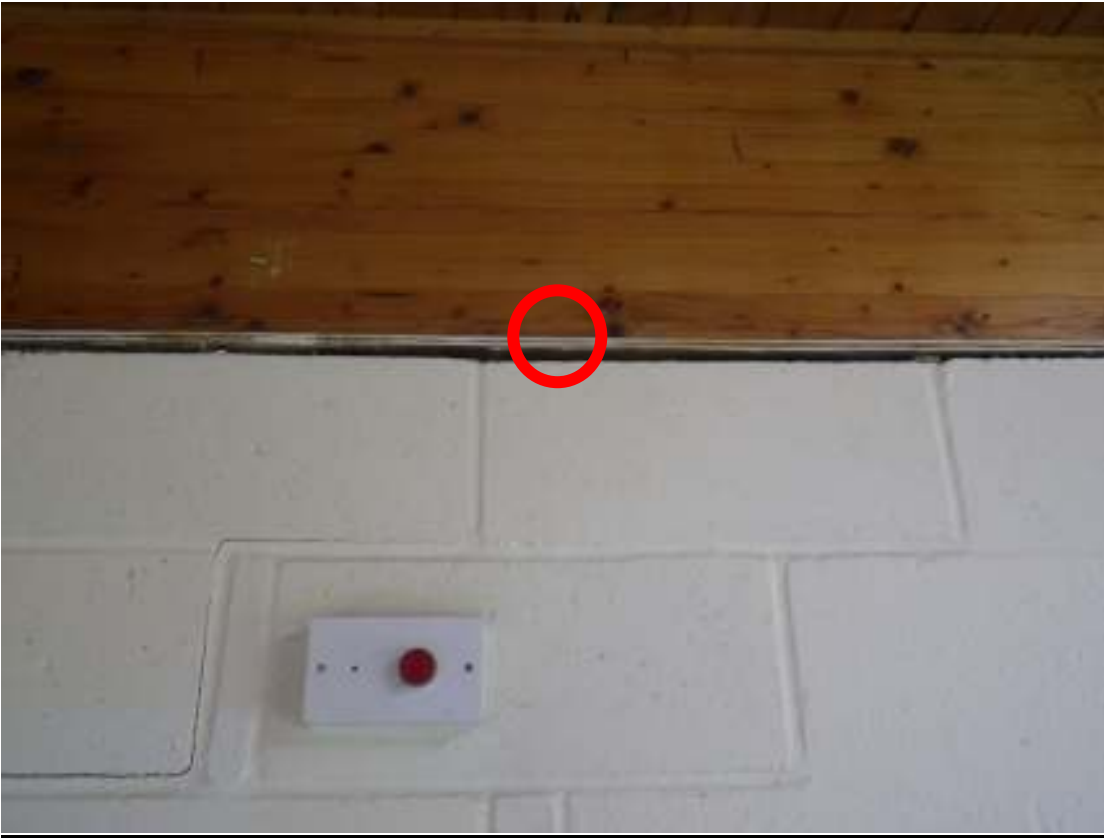
- 3.9 As a result of this, there are gaps between the tops of the walls and underside of the glulam beams. There is much cracking, up to 5mm wide in a number of places.

- 3.11 The **underlying cause is probably settlement of the fill under the building** due to inadequate compaction of the ground at the time of construction.

**Opening up under the timber glulam beams due to the concrete slab settling**

3.28 Based on what I have seen on 12<sup>th</sup> December 2023, I recommend the loose plaster is removed, the cracks filled with mastic and decorated.

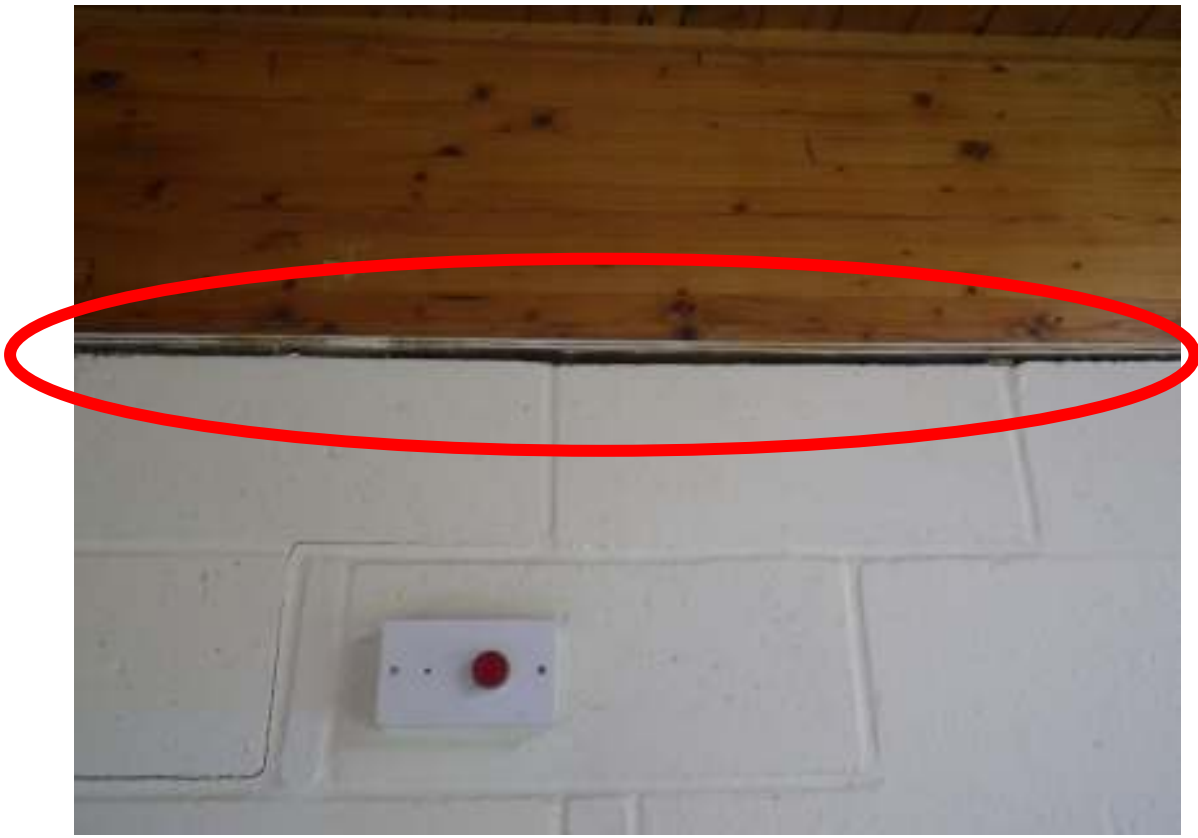
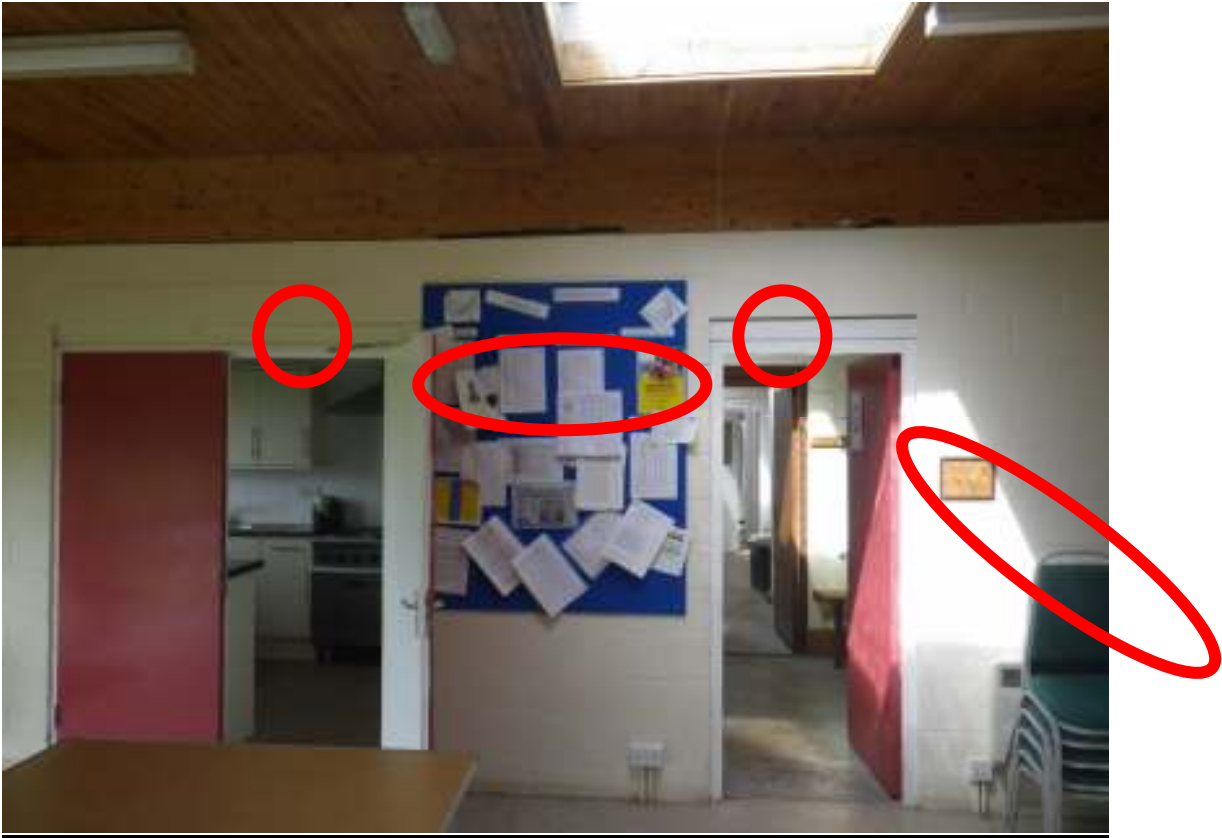
Cracking above the doorways

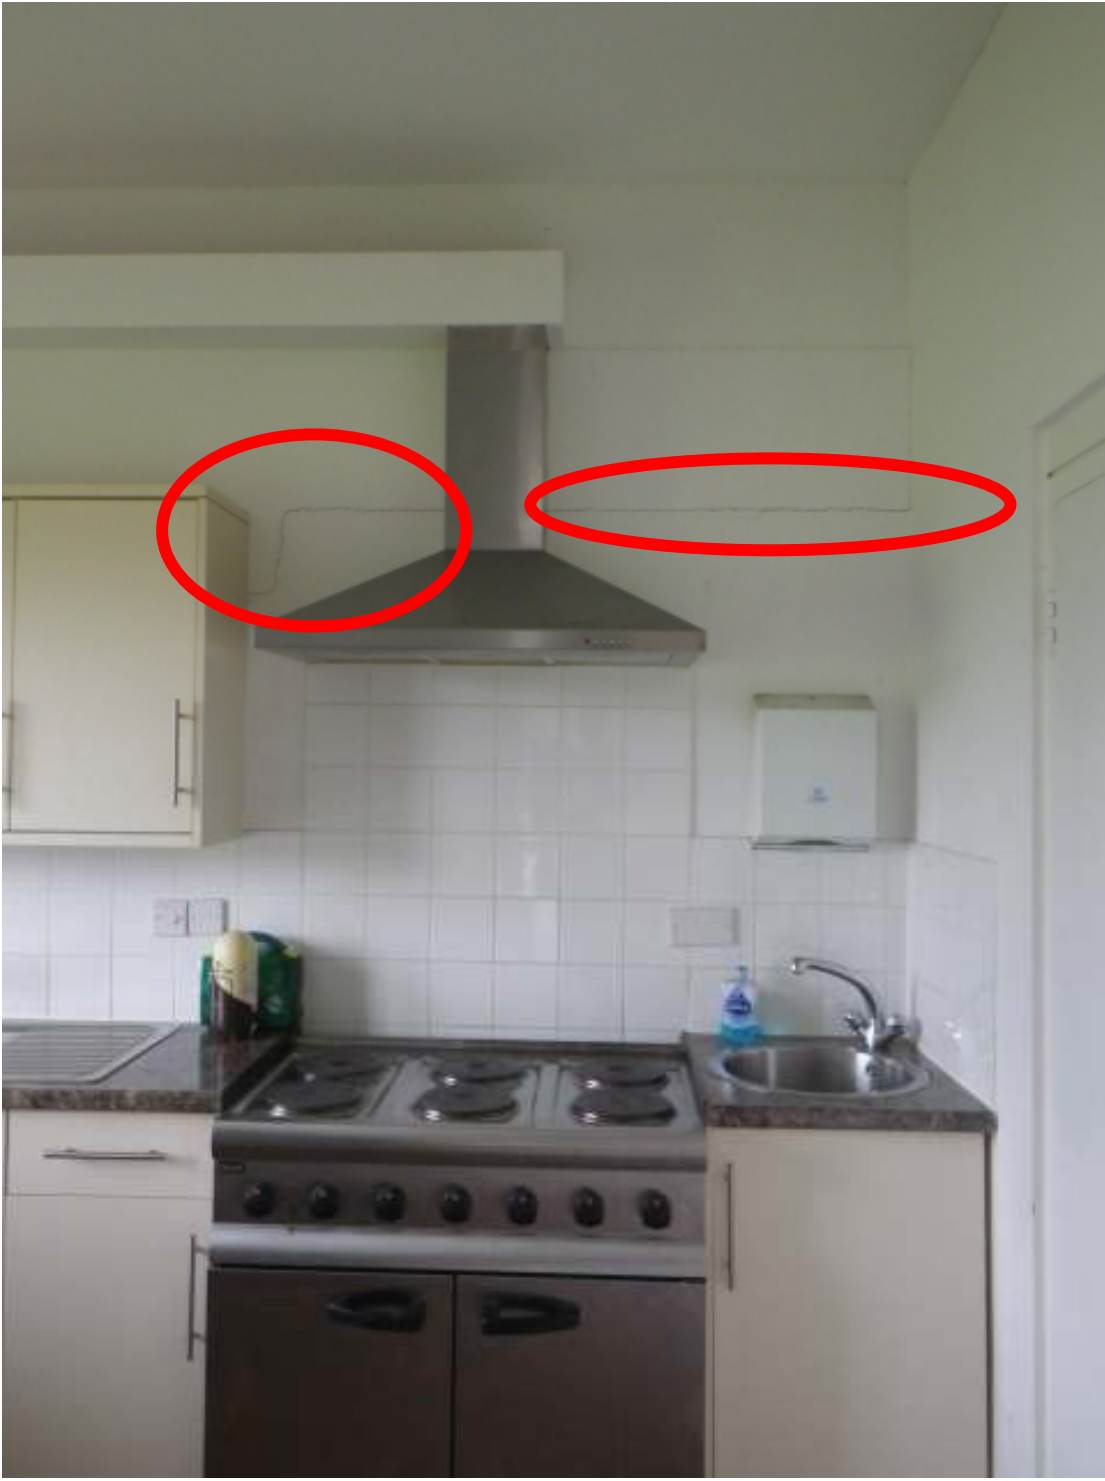
**Cracking in kitchen**

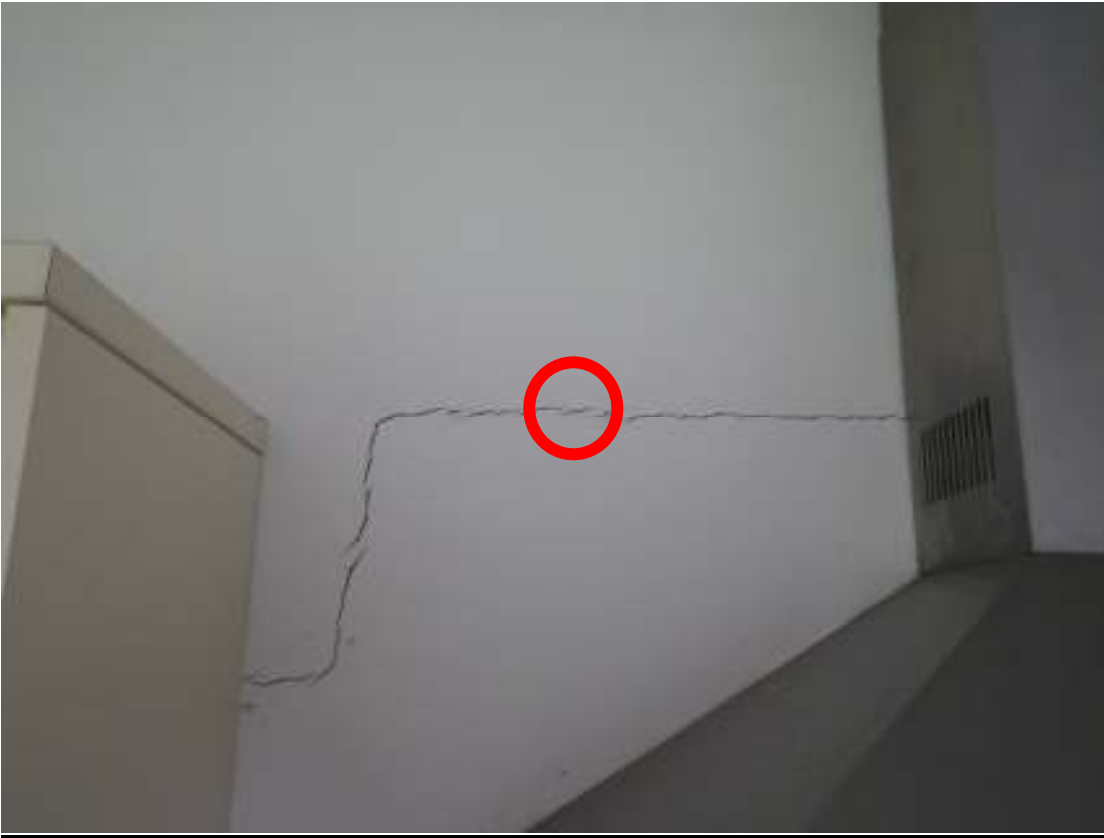
**Kitchen, cracking to left hand side of cooker hood in previous photograph**

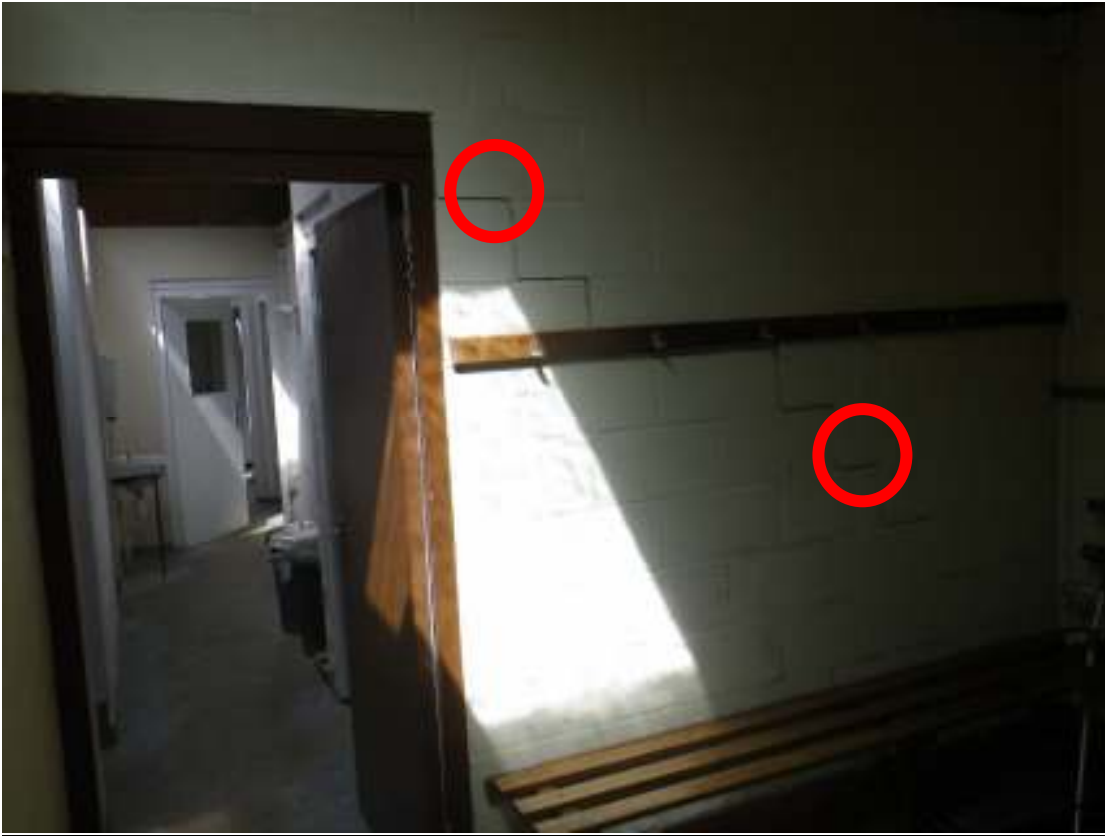
**Changing area, diagonal cracking to walls**

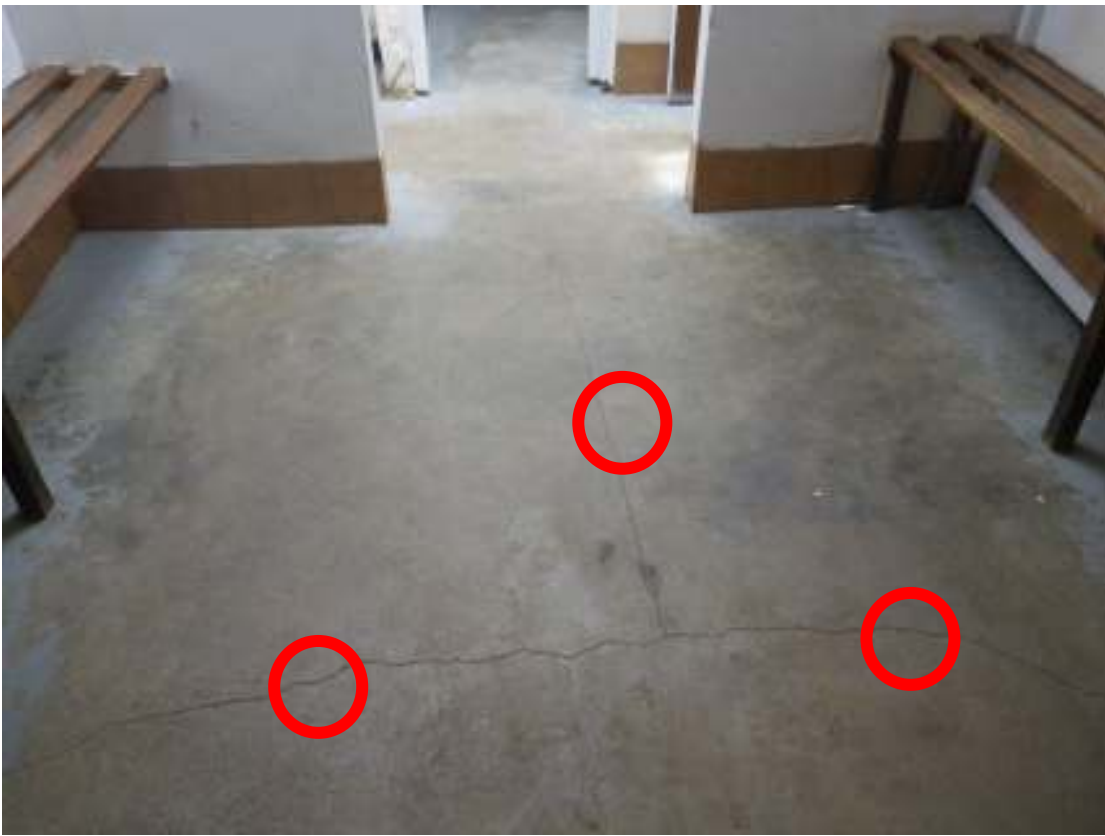
**Changing 1, cracking to the floor slab**

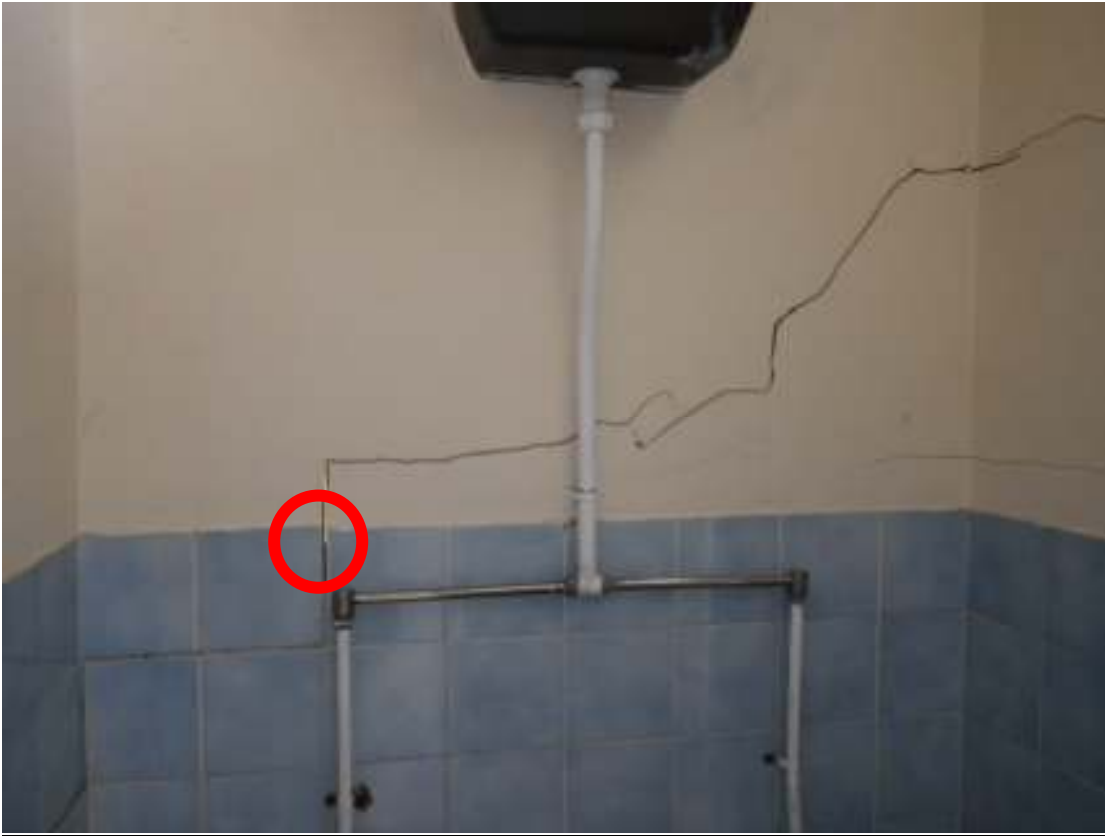
**Urinals. Cracking to wall**

Light visible through the crack to the plant room
