**The Bartholomew Building, Market Square,
Eynsham, Oxfordshire OX29 4HW**

Bat & Bird Survey Report

June 2021

***on behalf of* Eynsham Parish Council**

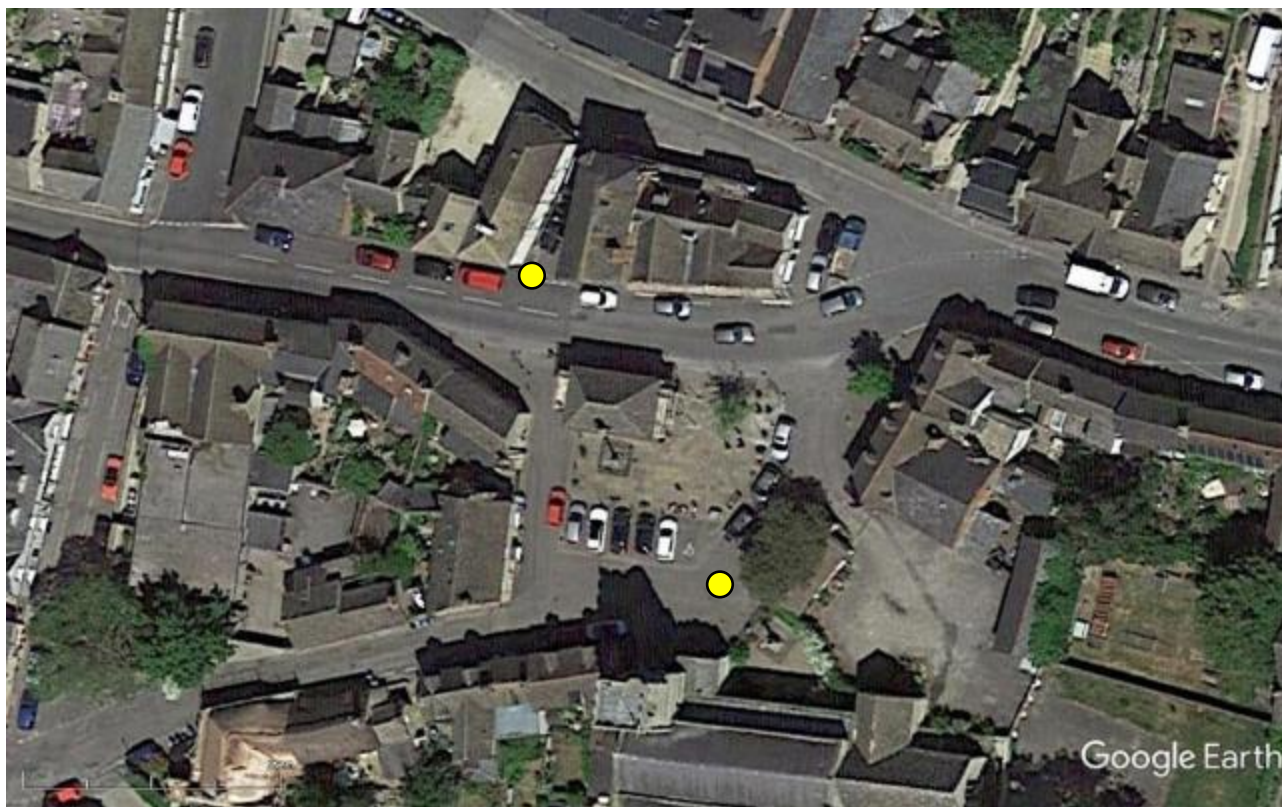
Figure 1. Position of the surveyors during the dusk emergence survey undertaken at the Bartholomew Building, Eynsham. The yellow dots indicate the location of the surveyors during the survey carried out at the building on the 1st June 2021.

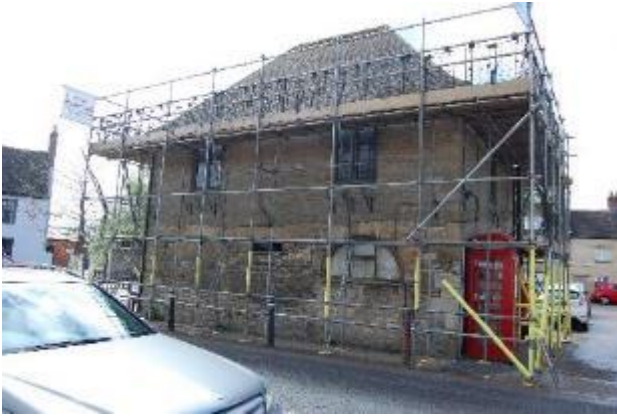
Photograph 1. The northern elevation of the Bartholomew Building.

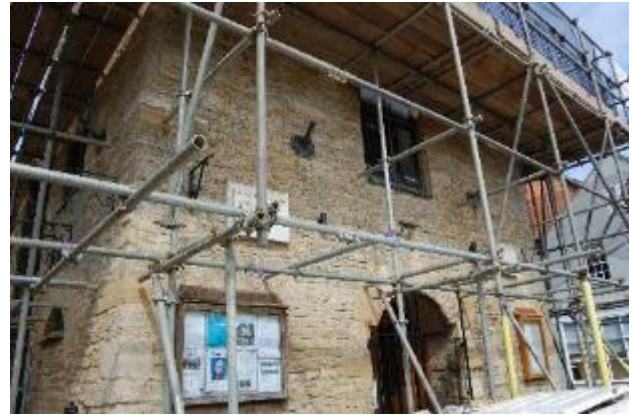
Photograph 2. Photograph showing eastern elevation of the building.

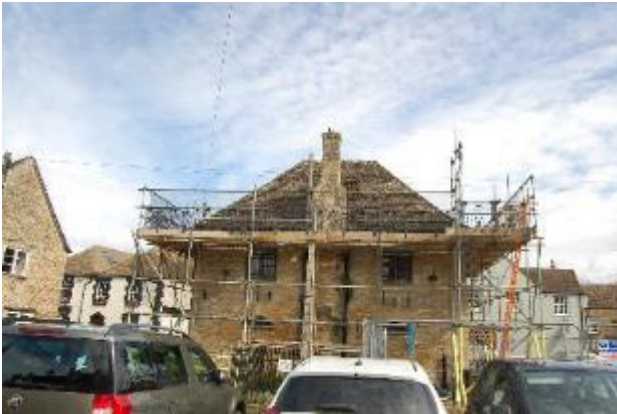
Photograph 3. The Bartholomew Building viewed from the south.

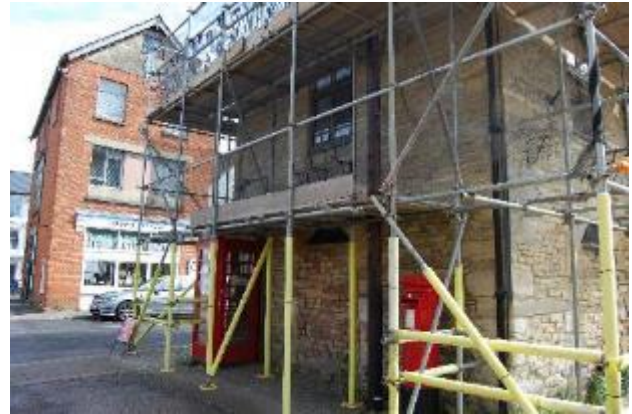
Photograph 4. Photograph showing the eastern elevation of the building.

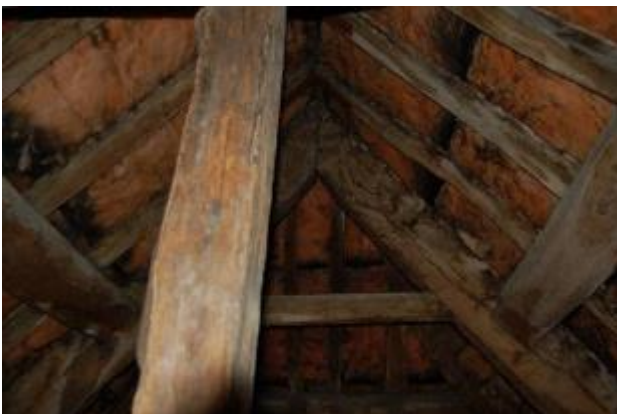
A single loft space covers the footprint. The roof is supported by a simple A-frame with a vertical central support post that is rotting. No ridge beam or board is present along the apex of the roof. The

Photograph 5. A view inside the loft space. Taken from the east looking west.

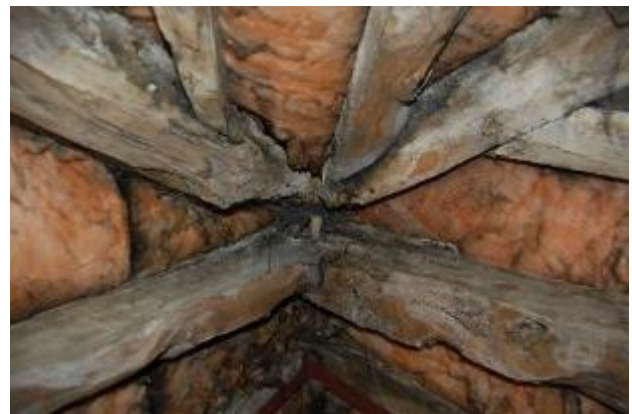
underside of the roof is covered with a bitumen and hessian underfelt, underneath which the roof has been further lined with fibreglass insulation. A small section of the bitumen and hessian underfelt can be viewed to the eastern side of the roof.

Photograph 6. Detail of the underside of the roof, which has been lined with fibreglass insulation, with bitumen and hessian roofing felt above.

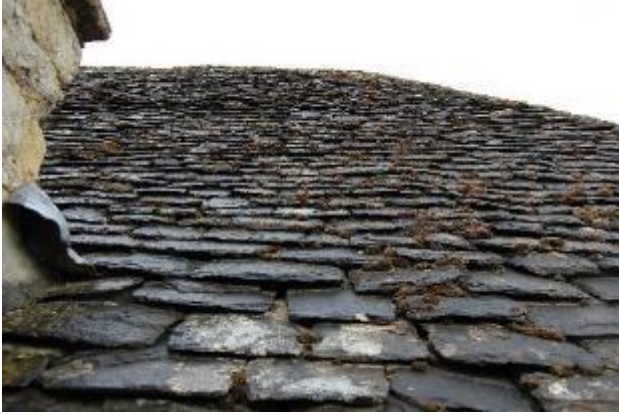
The roof tiles have a large number of naturally occurring gaps beneath them, there are also a small number of slipped and missing roof tiles. These gaps give bats the opportunity to access the batten space between the tiles and the underfelt, within which they could potentially roost.

The gaps below the roof tiles are relatively exposed as the tiles have seen some wear and tear creating larger than normal gaps beneath the roof tiles. Therefore, these gaps offer opportunities for individual bats on an opportunistic basis only. The features within the roof structure are not suitable for larger numbers of roosting bats on a more regular basis given the conditions. Furthermore, the immediate context of the site offers relatively poor foraging grounds for bats. More suitable foraging opportunities exist just beyond the edge of the village. Given the above discussion the Bartholomew Building is considered to have 'low' potential to offer shelter to roosting bats (Collins, 2016).

Photograph 7. Photograph showing the numerous naturally occurring gaps below the roof tiles.

Works to remove the roof tiles of the Bartholomew Building should proceed in a careful and controlled manner, with the removal of the roof tiles, by hand, checking below for any bats that may be present.

Contractors should be briefed with regard to the fact that individual bats can often exploit very small crevices as roost sites (such as gaps beneath roof tiles) and that bats can move between roost sites on a regular basis. They should remain vigilant for bats and any evidence of bats (bat droppings) when removing the roof tiles.

In the unlikely event that bats or significant evidence of bats (for example large accumulations of fresh bat droppings) are encountered, works should stop immediately, and advice sought from a qualified ecologist and/or Natural England.

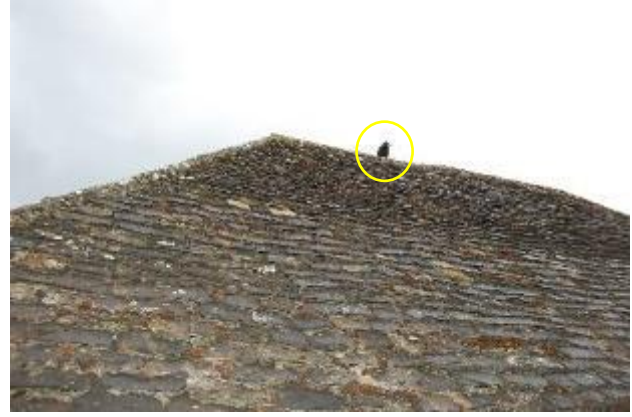
A jackdaw *Corvus monedula* nest appears to be present within the chimney on the south side of the building.

A parent bird was observed entering the chimney with what looked like food during the survey undertaken on the 11th of May, suggesting that chicks have hatched. Although no calling chicks were heard at the time. The jackdaw entered and existed on a small number of occasions within the duration of the survey.

Photograph 8. The jackdaw returning to the chimney with what appears to be food.

As there is a jackdaw nest within the chimney on the south side of the building, contractors should be briefed to the presence of the nest site and works to the roof in this area should be undertaken as carefully and sensitively as possible, in order that minimal disturbance is caused to the birds.

Before repair works to the chimney proceed, the jackdaw nest will need to be confirmed as inactive. A bird check of the Bartholomew Building will be required within 24 hours of commencing works to the chimney. If the nest is still active, works to the chimney will need to be delayed until a time when the young have fledged.
